# The Calaveras Fault West Branch

In Hollister, California

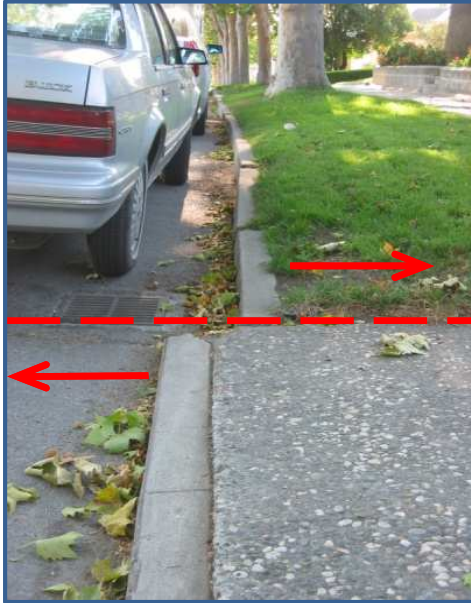
Right-lateral offset of curb at 6<sup>th</sup> Street near Dunne Park

Hollister has its faults .... of the earthquake kind, that is. The active Calaveras fault passes right through the City, making Hollister one of only a handful of places where active faulting can be seen at the ground surface in an urban area. All you have to do is take a walk. You can begin your tour of Hollister's seismic claim to fame by walking west along 6<sup>th</sup> or 7<sup>th</sup> Street to Dunne Park. The fault crosses through the park in a north-south direction. Take a careful look along the sidewalk and curbs of 6<sup>th</sup> or 7<sup>th</sup> street - you will see that they are shifted to the right (see photo). This condition is caused by "right-lateral" strike-slip (horizontal) movement of the fault since the sidewalk was constructed. Creep along the Calaveras fault is occurring at approximately 7 millimeters per year. A subtle linear hill in the grassy area of Dunne Park marks the location of the fault. The west-facing hill is called a scarp, and it shows that one side of the fault has moved upward relative to the other side. Similar offsets can be observed along many of the east-west streets in town.

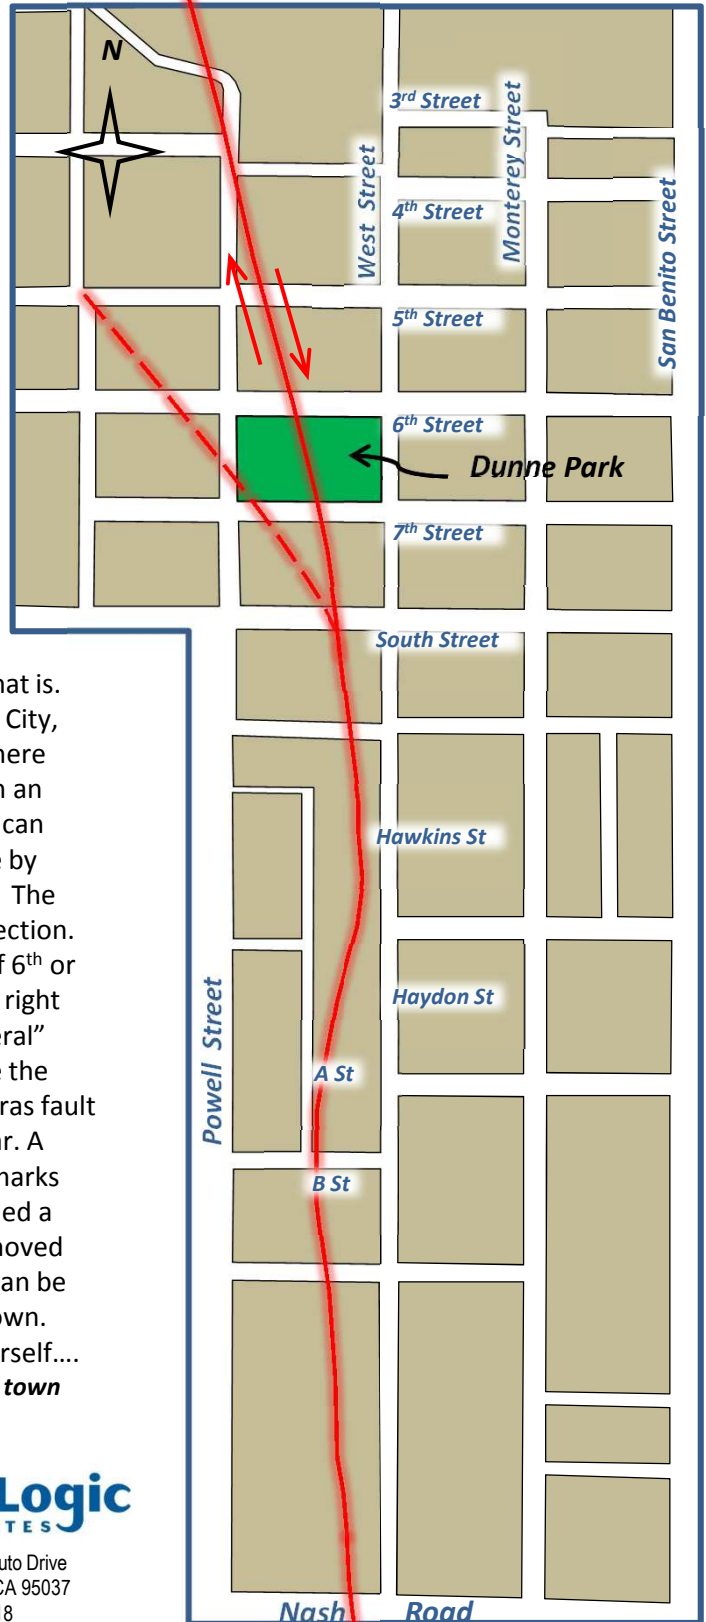
You can use the map at right to take a look for yourself....
